TPS65951 Silicon Errata

This document describes the TPS65951 bugs, limitations, and enhancements with suggested workarounds.

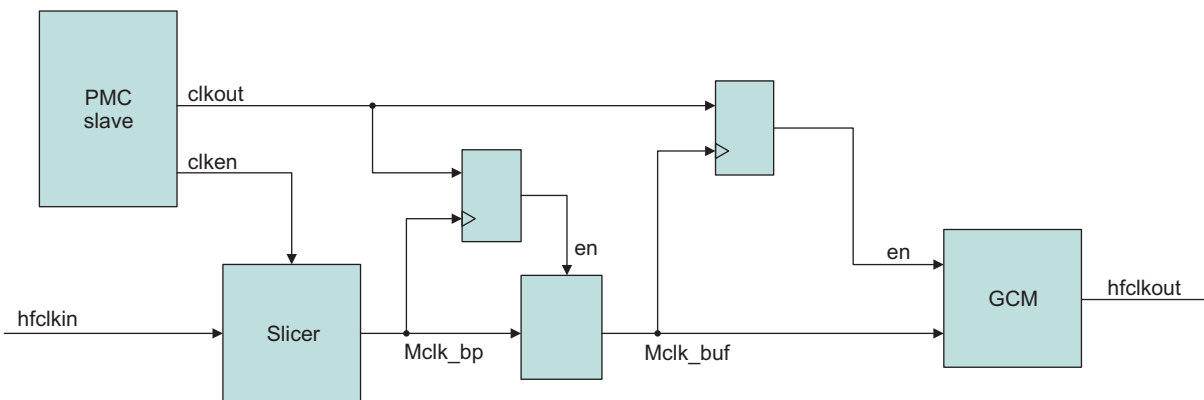
Figure 1. Block Diagram of HFCLKOUT Gating

9 Spikes occur on HFCLKOUT during switch on following an asynchronous switch off

After an asynchronous switch off (that is, PWRON_8s or WD-event), spikes occur on HFCLKOUT during the next switch on. The spikes occur after CLKEN is asserted, but before NRESPWRON is asserted. Because they occur before NRESPWRON, there should be no system impact.

Globally, HFCLKOUT is gated by the clkout signal resync on mclk, which is present only when clken is available (and hfclkin is present). See Figure 1.

- Normal/controlled switch off:
 - clkout is switched off before clken → the mclk clock is available after clkout goes low and the resynchronized enable of hfclkout GCM is properly disabled.
- PWRON_8s and any “async” switch-off events like watchdog:
 - clkout and clken are reset together → the resynchronized enable stays high until the next mclk clock cycle, which comes during the next switch on (when clken and hfclkin are present), so the hfclkout will be gated after one or two hfclkin clock cycles only. Due to this, spikes are seen on HFCLKOUT during the switch on following an asynchronous switch off.

No workaround.
